# **Town Center Planning Project**

## **Synthesis of Past Reports and Assessments Concerning the Civic Center Building**

# CITY OF MOUNTLAKE TERRACE

### Synthesis of Past Reports and Assessments Concerning the Civic Center Building

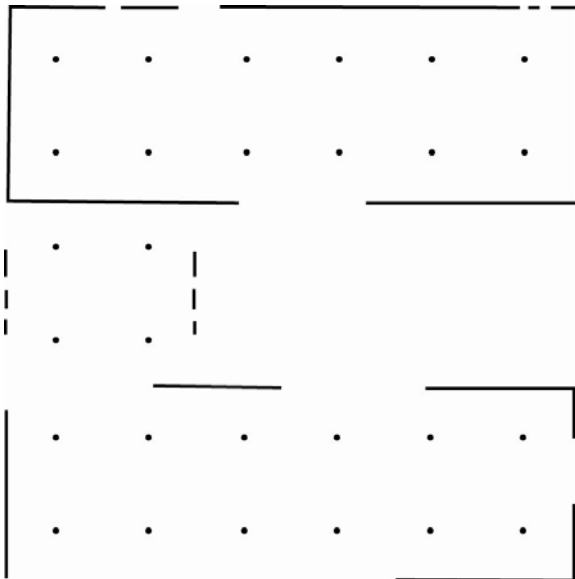
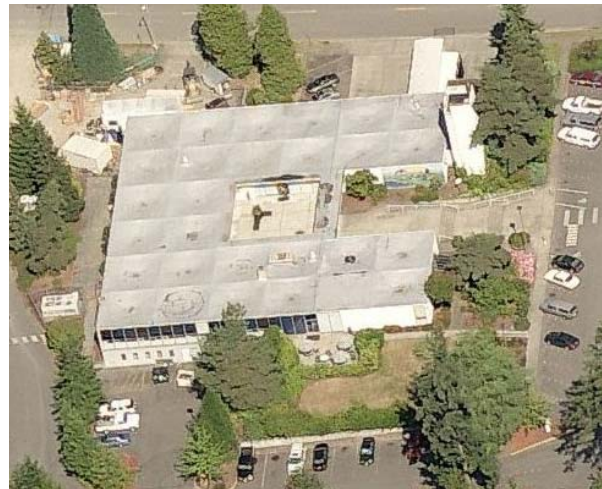
Exhibit 8 illustrates the building's structural support system: each circle is one roof panel support column, and the heavy lines are the structural walls. Note the short length of the wall on the southern side—the rest of the southern wall is comprised mostly of windows.

The 1993 structural assessment found that the masonry blocks are not strong enough; the mortar joining the blocks is not strong enough; the method of joining the walls to the floor is not strong enough; the method of attaching the wall to the roof panels is not strong enough; the roof-supporting
